Inspection Report

Minerals Regulatory Program

Mine Name: Two More Feet
Operator Name: Scott Higley

Permit number: S0130007
Inspection Date: September 12, 2007
Time: 11:20-11:35 AM

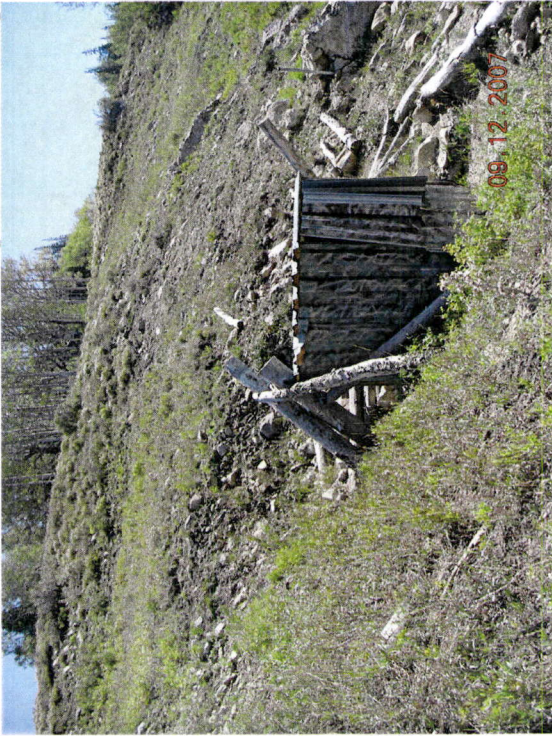
When I last visited this site in 2003, it had consisted of some log cribbing with logs and a tarp for the roof. The operator has now built a more permanent structure with steel and log siding and a steel roof (Photos 1-3). One of the pieces of siding was loose which allowed me to look inside and take Photo 4.

Photo 1. This and Photos 2 and 3 show various views of the above-ground portion of the structure.

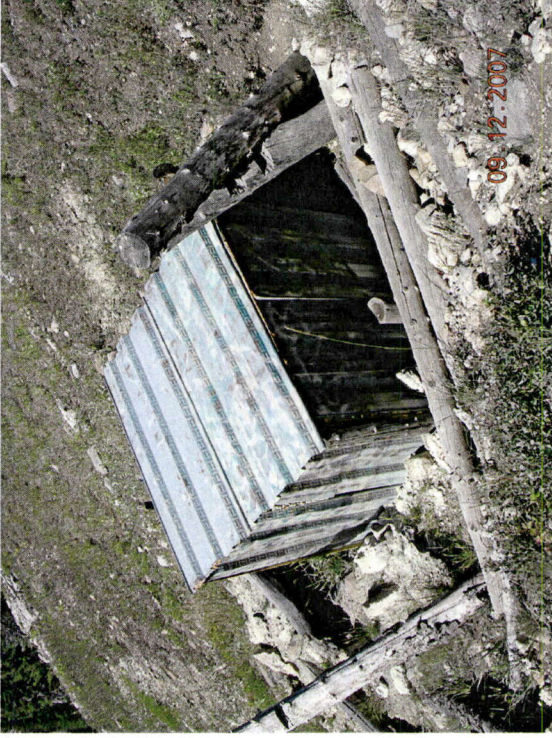
Photo 3. Another view of the structure.

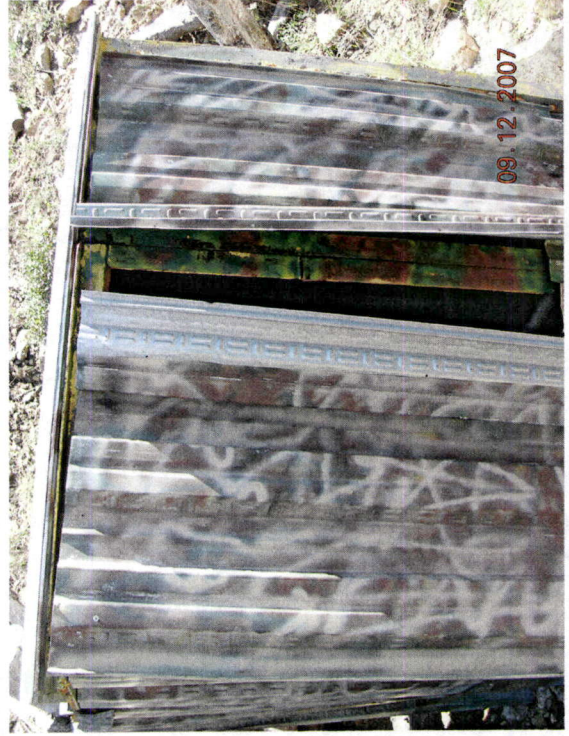
Photo 2. Part of the siding was loose.

I suggest that the operator better secure the metal siding. This site is remote and difficult to find unless a person knows where it is, but there is still the potential for vandalism and theft. The shaft is shallow enough—at least the portion I could see—that I don't believe there is much danger to the public.

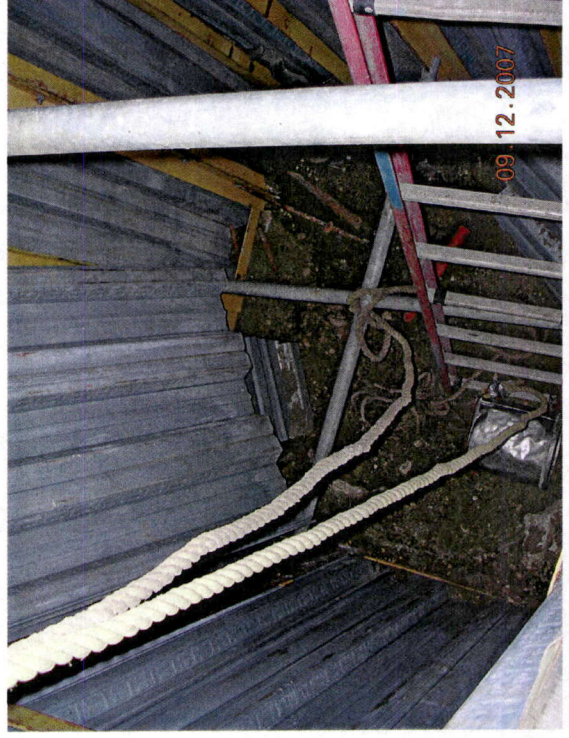
The interior of the structure has a floor, but the operator explained to me in a 2003 phone conversation that it is a false floor and that he has been taking some material from a fissure near the small shaft.

Photo 4. A view inside the structure.
